# Straw bale wineries

## Wallington Wines

## Valhalla Wines

*Straw bale winery with a Viking slant*

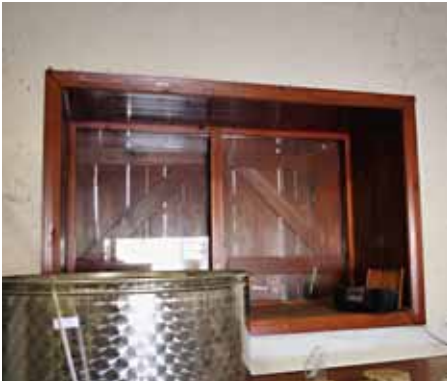
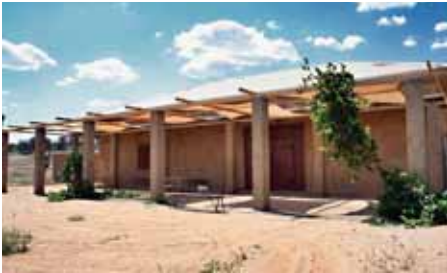
*Clockwise from above: The southern verandah offers stunning views over the vineyard; A deep reveal created by the single window functions as a serving hatch during tastings; The temperature remains constant – perfect for maturing wines; The outdoor wet area to the north; The final product.*

The building is oriented along an E-W axis, with no openings on the east and west walls. The north wall has only one opening, a roller door for access. The southern wall has a large wooden doorway and a window covered with heavy wooden shutters. The openings for these were made to bale sizes, to minimise the amount of cutting of bales required, and the door and window were then made to fit the gaps.

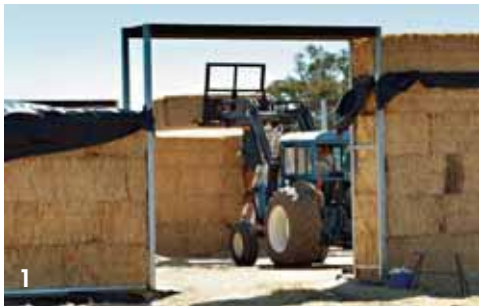
1

1. The old Ford 5000 in action.
  2. Scissor trusses going on.
  3. Double layer of insulation for roof.
  4. John Glassford helps with gable end infill.
  5. Third and last coat of render going on.
  6. Handmade by William 'de la doors' Banks - 0408 101 187.
  7. First coat finished.
  8. Third coat of render drying in the sun.
  9. Interior with great temperature control.
- Photos by Anton Therkildsen unless indicated.

The farm tractor with front-end loader was used for the heavy lifting, ensuring the bale walls went up in record time. The top plate was fitted, and wired down to the footings.
